THE CORROSION PRODUCTS OF IRON AND THEIR RELATION TO CORROSION IN STEAM-GENERATING EQUIPMENT

# THE CORROSION PRODUCTS OF IRON AND THEIR RELATION TO CORROSION IN STEAM-GENERATING EQUIPMENT

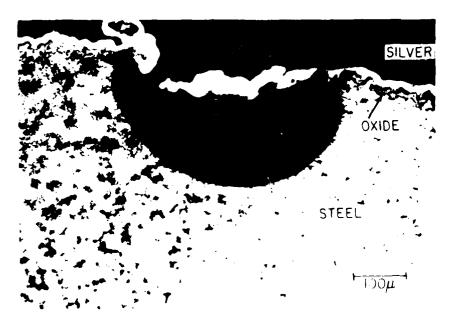
the corrosion rate in pure water at 316°C has been reduced to less than 10 mg/dm2mo, which is the equivalent of about 6 millionths of an inch per year, and that even at a pH of 11.5, the rate has been reduced to the order of about 20 mg/dm<sup>2</sup>-mo or about 12 millionths of an inch per year. If, however, the sodium hydroxide concentration reaches 40%, the rate goes down with the buildup of a protective film for a day or two; thereafter, the rate increases rather rapidly. It may be noted that the 15% sodium hydroxide constitutes an intermediate case. If we remove a sample corroding in 40% sodium hydroxide at 316°C after passing the minimum in the corrosion rate, we rind that pits have started to develop in the tubing which, starting at some sensitive spot, rapidly drill a hole in the tubing (see Figs. 2 and 3).

Fig. 2 - Section near the end of the capsule that contained 40% sodium hydroxide solution and was treated at 316% C for 46% hours. The specimen was silver plated before mounting to preserve the oxide during the polishing operation. A 1% nital etch was used.

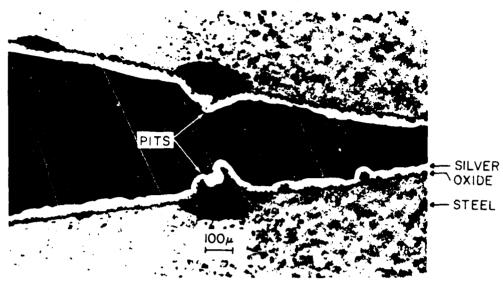
to a minimum may be noticed here as in the 40% sodium hydroxide case and then the rise, but now the action is more gradual and one can study the pit development more adequately. Figure 6 shows the pit formation shortly after passing the minimum. Samples taken at subsequent times show the development of more and more pits until at the end of a year of operation, pits overlaid with fractured scabs cover the entire surface of the tube as shown in Fig. 7. If we take a section through one of these scabs and examine it at high magnification, we observe what is seen in Fig. 8.

Fig. 6 - Section perpendicular to the inside surface of the steel capsule containing 15% sodium hydroxide solution after 68 days at 316 C. The original magnification was 100X. The specimen was silver plated before mounting to preserve oxide during polishing operation, and a 1% nital etch was used.

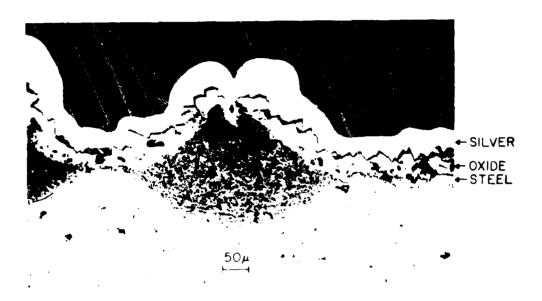
Fig. 8 - Section perpendicular to the inside surface of the steel caps decontaining  $\Gamma_0$  sodium hydrox de solution after 1 year at 316 C. The original magnification was 200X and a  $\Gamma_0$  mital etch was used.
